Amendment 39-17948; AD 2014-16-24]

Airworthiness Directives; Airbus Helicopters Deutschland GmbH (Previously Eurocopter Deutschland GmbH) (Airbus Helicopters) Helicopters

ACTION: Final rule.

2014-16-24 Airbus Helicopters Deutschland GmbH (Previously Eurocopter Deutschland GmbH) Helicopters: Amendment 39-17948; Docket No. FAA-2014-0034; Directorate Identifier 2013-SW-006-AD.

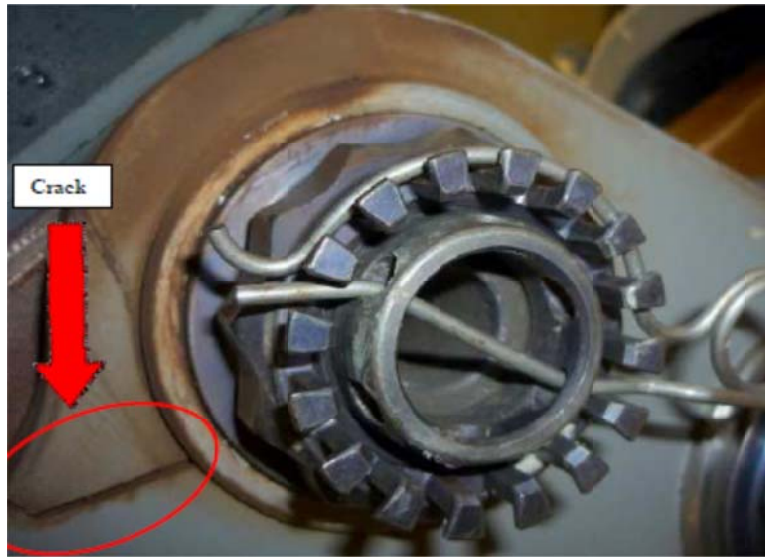
Figure 1 to Paragraph (f)(1)

This AD defines the unsafe condition as a crack in the MRH shaft flange, which could result in failure of the MRH and subsequent loss of control of the helicopter.

(1) Before further flight, and thereafter at intervals not to exceed 6 hours time-in-service (TIS), check the MRH shaft lower flange and the visible area of the MRH shaft upper flange for a crack. Figures 1 and 2 to Paragraph (f)(1) of this AD are examples of cracks that have been discovered in the MRH shaft lower flange. The actions required by this paragraph may be performed by the owner/operator (pilot) holding at least a private pilot certificate, and must be entered into the aircraft records showing compliance with this AD in accordance with 14 CFR §§ 43.9 (a)(1) through (4) and 14 CFR § 91.417(a)(2)(v). The record must be maintained as required by 14 CFR §§ 91.417, 121.380, or 135.439.

(3) If there is a crack in the upper or lower MRH shaft flange, before further flight, replace that MRH shaft with an airworthy MRH shaft. Replacing the MRH shaft with an MRH shaft having a P/N listed in paragraph (a) of this AD does not constitute terminating action for the requirements of this AD.
